DIAMOND HEAD HOME INSPECTIONS

INSPECTION REPORT

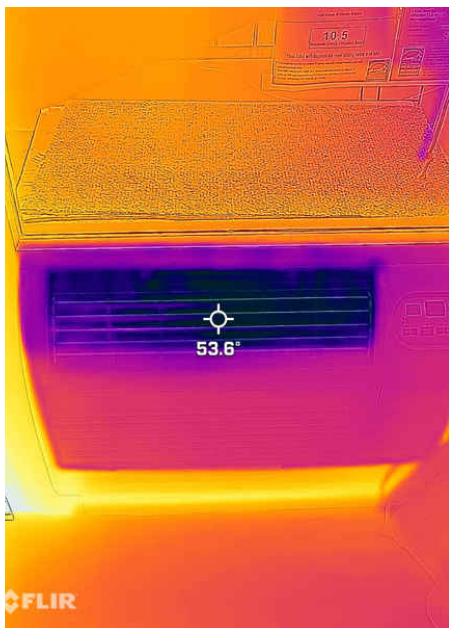
Living Room

The window A/C units are operable and functioning properly at the time of inspection. The air temperatures are observed at acceptable levels.

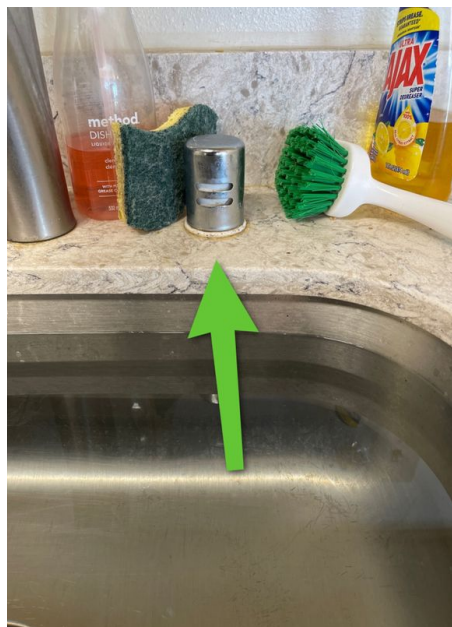
Dishwasher: Air gap

The dishwasher is equipped with an air gap installed at the drain line. The air gap helps to prevent drainage back flow/contamination issues and the creation of a vacuum from the waste lines.

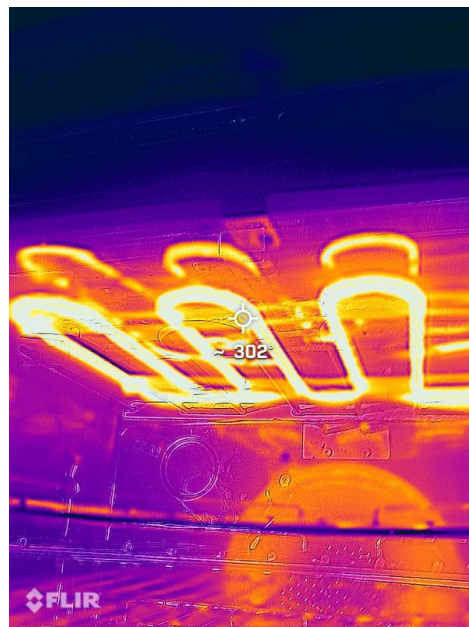
Oven: The upper and lower oven elements/burners have been tested at the time of inspection

The unit and elements/burners are functional and in acceptable condition. Appliances can fail at anytime without warning. No warranty, guarantee, or certification is given as to future failures.

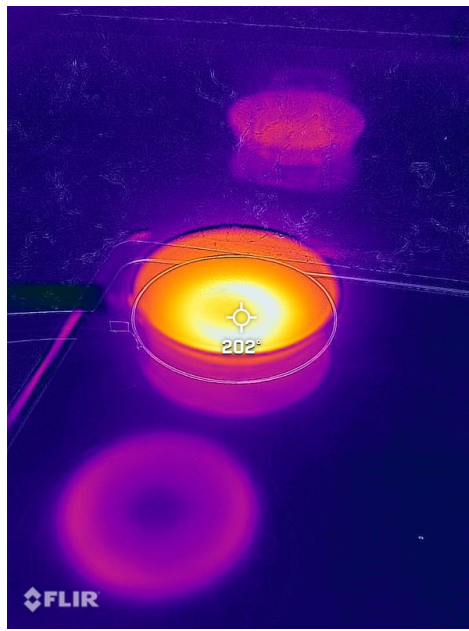
Range: All heating elements are operable and functioning properly at the time of inspection

All heating elements are operable and functioning properly at the time of inspection. The Inspection does not include calibration as this is not a technically exhaustive inspection. No warranties or guarantees of this or any other appliance can be offered.

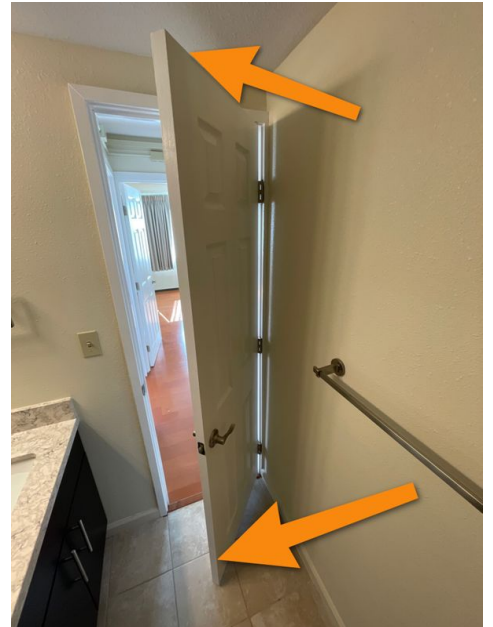
4.5.1 Doors and Closets

THE DOORSTOP IS MISSING

ALL ROOMS AND BATHROOMS

Recommend evaluation and installation/replacement where needed.

Contact a qualified professional.

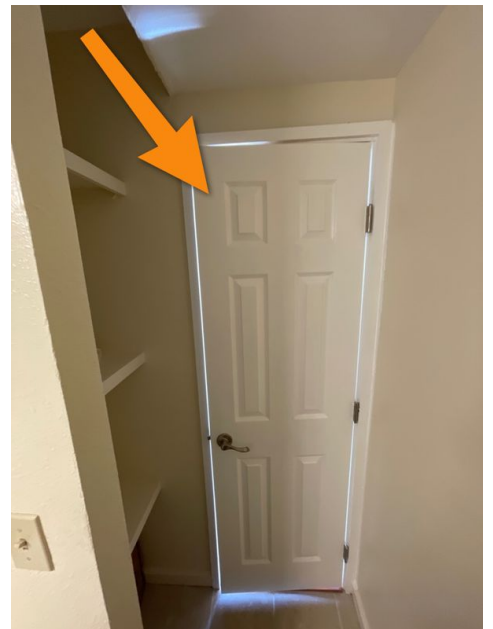
4.5.2 Doors and Closets

TIGHT IN THE JAMB

MASTER BATHROOM

The door is tight in the jamb. Recommend evaluation and repair/adjustment to the hardware as needed.

Contact a qualified professional.

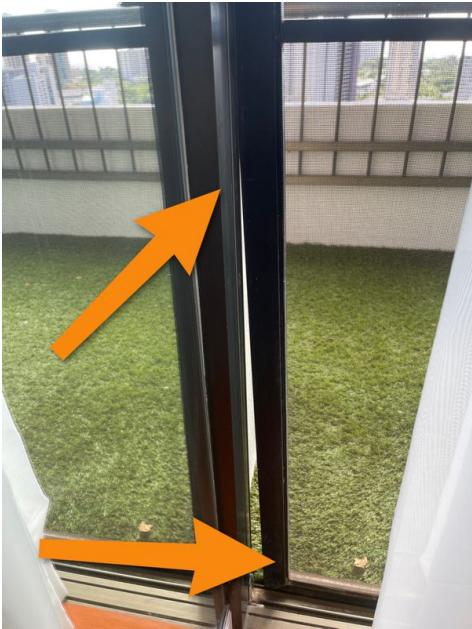
4.5.3 Doors and Closets

SLIDING SCREEN

The sliding screen door in the family room is out of alignment. Recommend repair.

Contact a qualified professional.

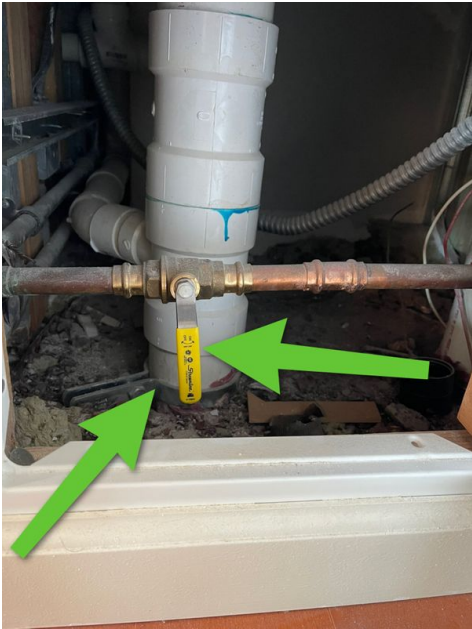
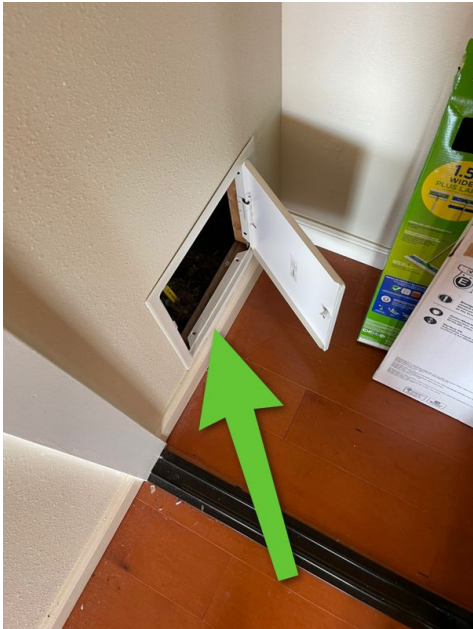
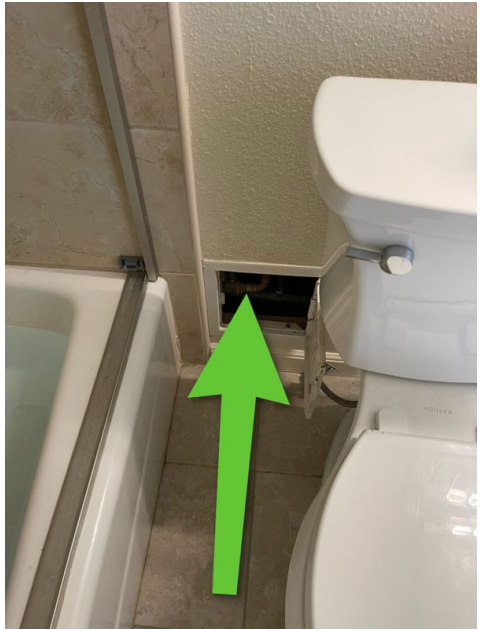
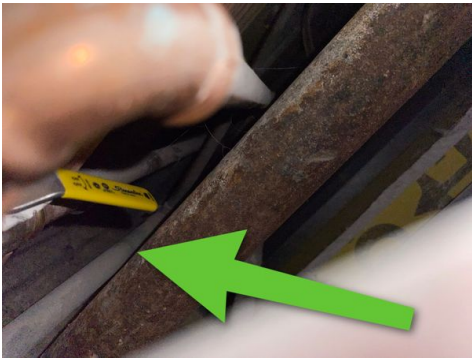
COLD WATER MAIN VALVES

Cold water main shut off valves are located inside access panels in the entry closet and by the bathroom 2 toilet. Unable to locate shut off valves for the hot water supply. Recommend further evaluation.

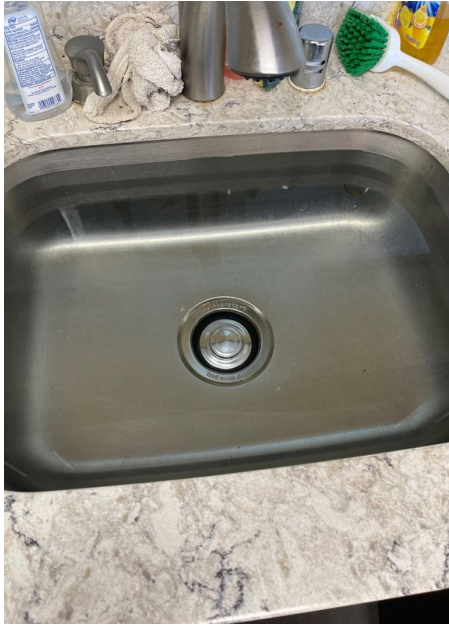
Kitchen

The sinks are functional and observed in acceptable condition. The faucets are operational and the water pressure/flow is satisfactory. The drainage plumbing and flow are generally acceptable and no leaks have been detected at the time of inspection.

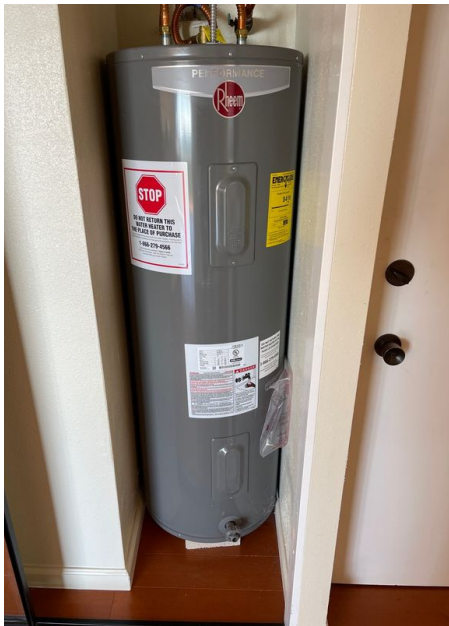
Condition: Acceptable

The water heater is operable and functioning properly at the time of inspection. There are no indications of leaks and the unit is observed in acceptable condition. Unable to visually inspect the interior components of the water heater, and therefore cannot determine longevity. Water heaters can fail at any time regardless of age due to a number of factors which cannot be determine during the inspection. These factors may include water quality, maintenance, quality of the components, exposure to the elements, etc.

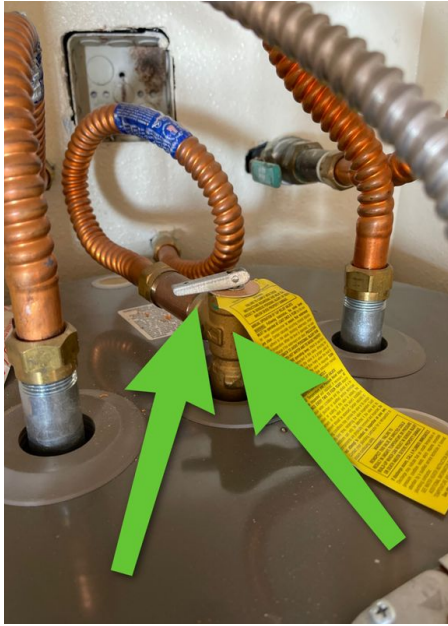
Automatic Safety Control: TPR Valve: Acceptable and Not Tested

The water heater TPR valve has not been tested at the time of inspection. Engaging the TPR valve can cause the device to leak because the seal may not reseal properly. The unit is believed to be in acceptable condition based on the age and lack of corrosion. Recommend evaluation/testing to ensure proper function.

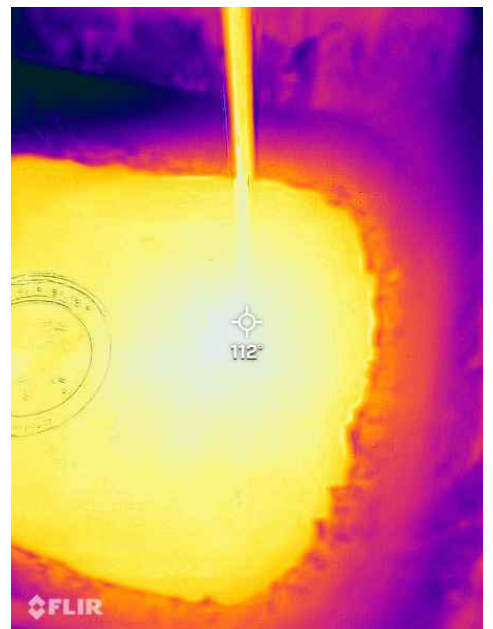
7.1.1 Condition

The hot water temperature is observed at 112 degrees F. This is below the acceptable level. Recommend increasing/adjusting the water heater thermostat to a temperature between 116-122 degrees F to prevent possible bacterial growth.

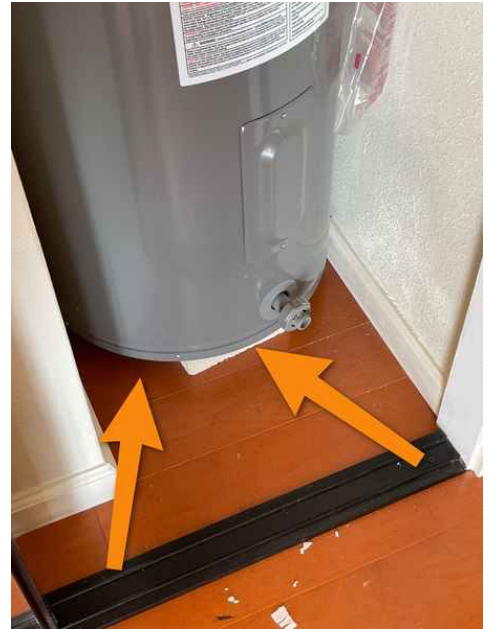
7.1.2 Condition

NO CATCH PAN INSTALLED

There is no catch/drain pan installed beneath the water heater. The water heater is installed over a finished living space. Consider installing a catch/drain pan to help prevent water damage if the tank were to leak.

Contact a qualified professional.

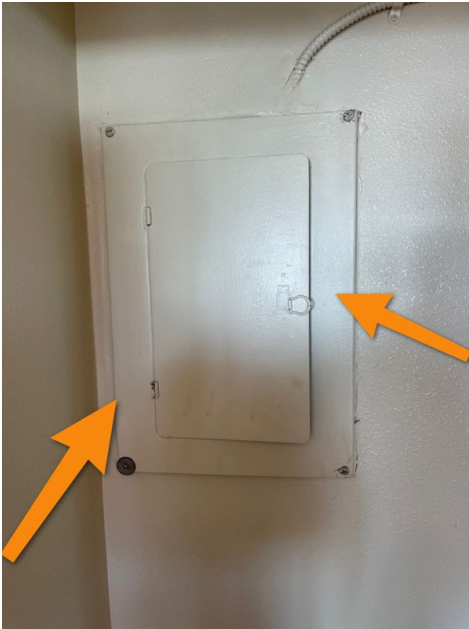
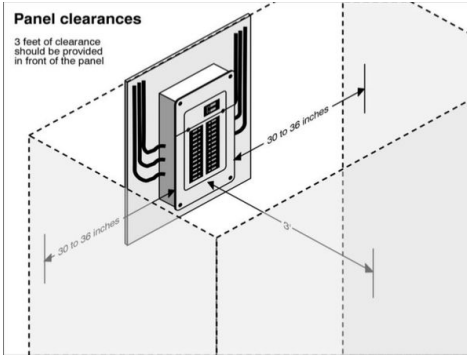
Access to the sub electrical panel is restricted and/or difficult. Current standards require direct clearance to all electrical panels in case of emergency or repair. Recommend review of the provided graphic for the proper measurements and repair as necessary.

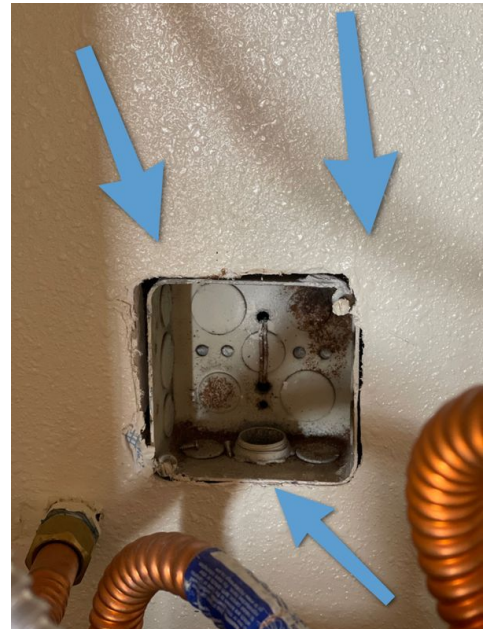
8.5.1 Branch Circuit
Conductors/Wiring/Compatibility

ONE J BOX COVER MISSING

There is an open junction box observed behind the water heater albeit no wires are present inside. Recommend repair/replacement of the cover plate.

Contact a qualified professional.

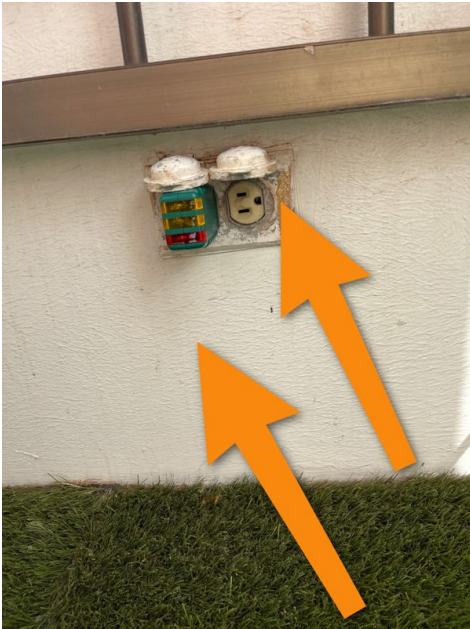
8.7.1 GFCI/AFCIs

NO GFCI

There are electrical outlets observed on the lanai that are not GFCI rated. GFCI protection may not have been required at the time of original construction. Recommend evaluation and upgrading to GFCI outlets by a licensed electrician.

Contact a qualified professional.

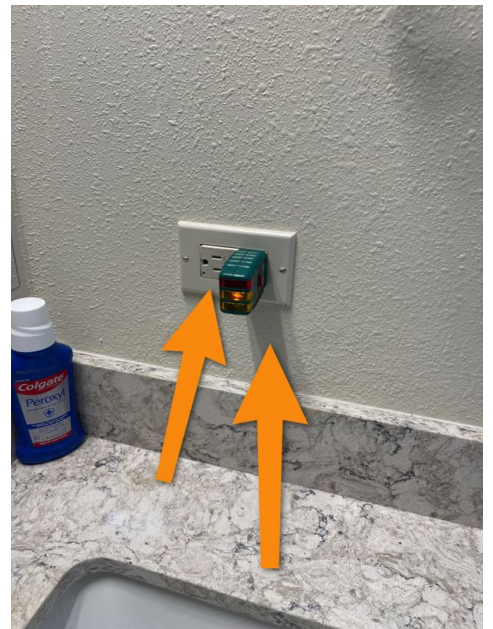
8.7.2 GFCI/AFCIs

GFCI DOES NOT TRIP

There are GFCI outlets located in both bathrooms that do not trip properly when tested. Recommend repair/replacement by a licensed electrician.

Contact a qualified professional.

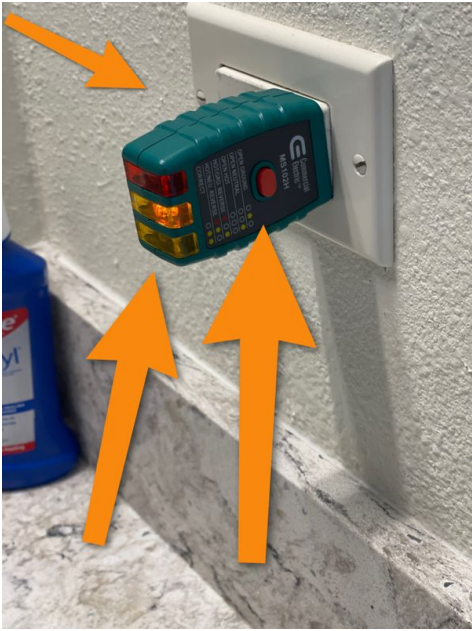
8.9.1 Outlets/Receptacles

OUTLET TESTING IMPROPER

There are one or more electrical outlets that tested open ground. Recommend further evaluation and repair/correction by a licensed electrician.

Contact a qualified professional.

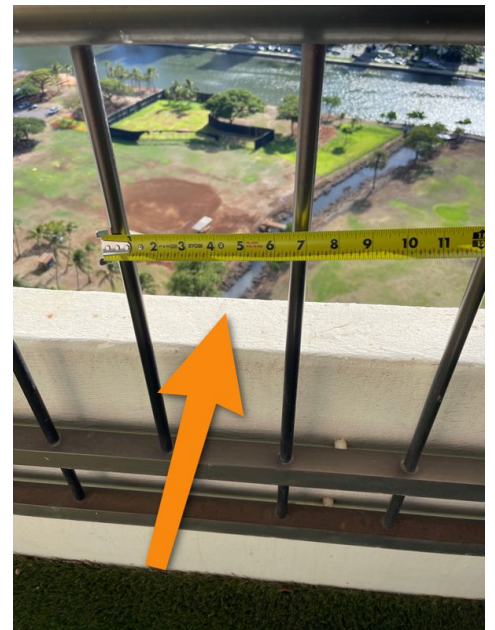
9.8.1 Porch, Patio, Balcony, Decks, and Carport Condition

The observed spacing between the patio guardrail spindles is wider than the currently recommended standard. This standard requires the spacing between the spindles/rails be no wider than a four inch sphere for child safety. Recommend upgrading or using caution in this area.

Contact a qualified professional.

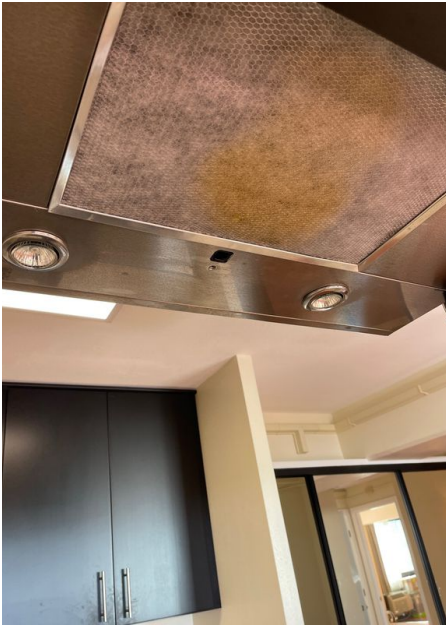
Kitchen: Acceptable

The kitchen ventilation system is operable and functioning properly at the time of inspection
